MAGNESIUM-OXIDE BOARDS CAUSE MOISTURE DAMAGE INSIDE FACADES IN NEW DANISH BUILDINGS

Kurt Kielsgaard Hansen ⁽¹⁾, Tommy Bunch-Nielsen ⁽²⁾, Bent Grell ⁽¹⁾, Carsten Rode ⁽¹⁾

(1) Technical University of Denmark, Lyngby, Denmark

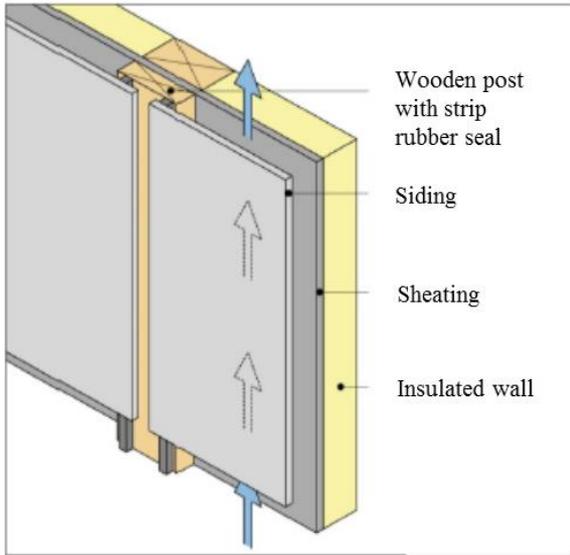
Figure 1: Sketch of a typical façade construction where a sheathing board is used as wind barrier. Adapted from [1].

In winter 2014/15, many moisture damages were observed inside ventilated facades of new or newly renovated Danish buildings. The moisture damaged facades were constructed with sheathing made of magnesium oxide-boards (MgO-boards) facing the air gap behind the material used for exterior siding. MgO-boards have often been used as sheathing behind a ventilated air gap as shown in Figure 1 and Figure 3. A photo of a MgO-board is shown in Figure 2.

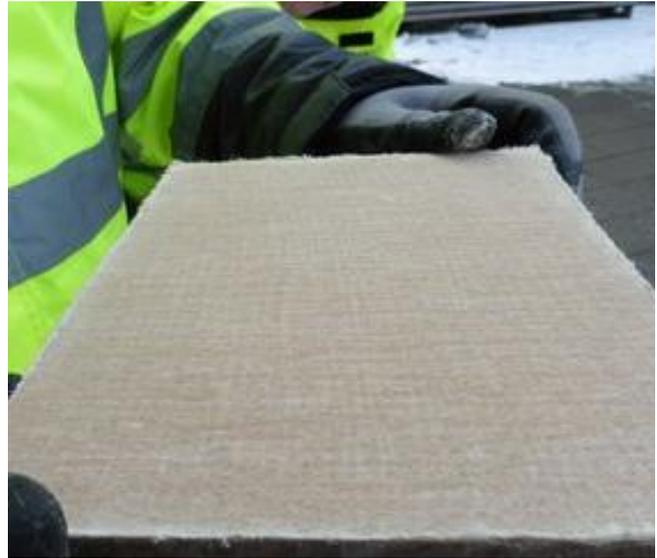
Figure 2: Photo of 8 mm thick MgO-board with a glass fibre mesh on both surfaces.

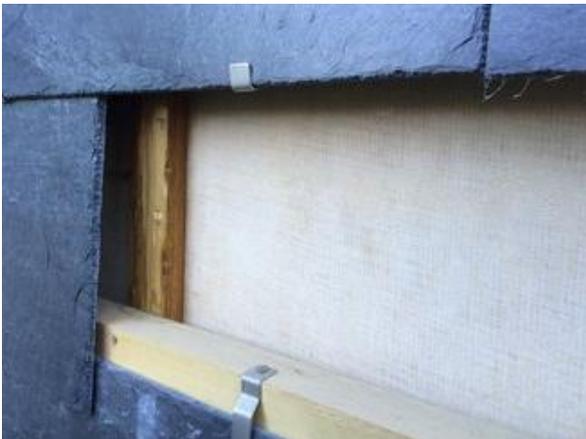
Figure 3: The MgO-board is placed facing the air gap, which is behind the siding boards made of natural slates.

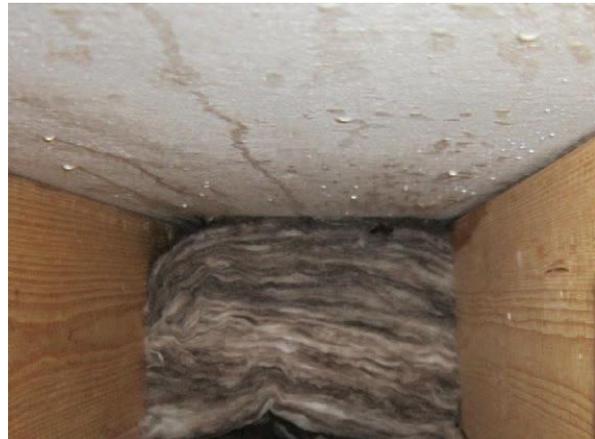
Figure 4: Salty water drops on a vertical MgO-board on the side that faces the insulation filled cavity inside the wall.

The observed damages were caused by the fact that MgO-boards absorb moisture from outside air. Water drops containing chloride ions appear on the outside of the boards – often so many that they run down the vertical boards and out via the air gap behind the siding boards (see Figures 4 and 5). The metal mountings for the MgO-boards can corrode heavily within a few years, cf. Figure 6.

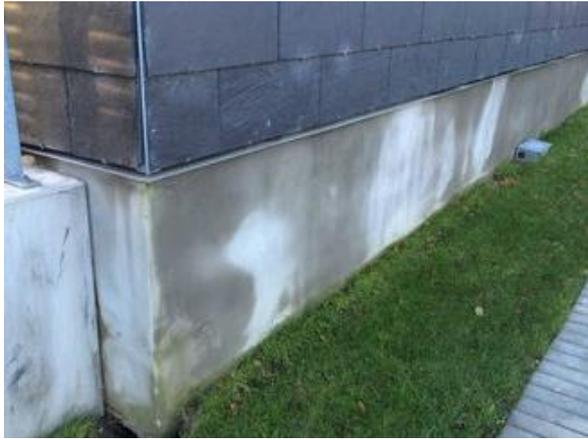
Figure 5: The water drops containing chloride ions run down the vertical MgO-boards and drain out of the wall from behind the wall's siding boards.

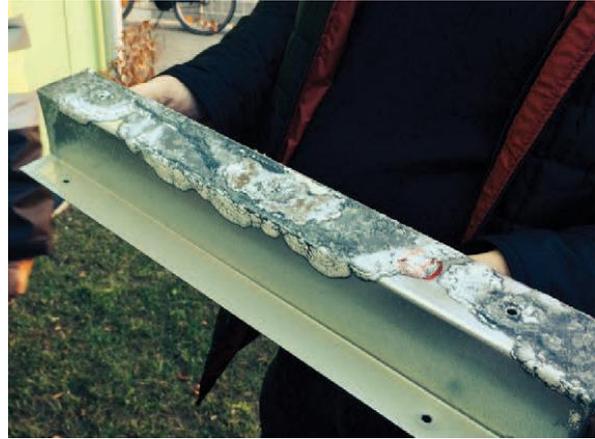
Figure 6: The zink covering of the steel profile is corroded as a result of direct contact with salty sweat or 'tear' drops from the adjacent MgO-board.

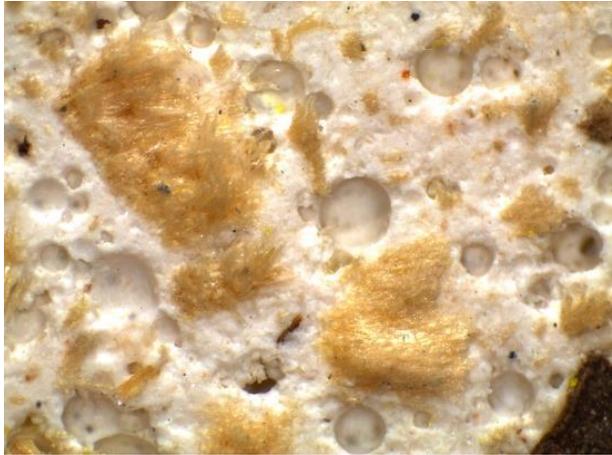
Figure 7: Cut of a MgO-board investigated in a stereo microscope at 10 times magnification.

The hydrated product is hard and strong but the product decomposes over time by contact with water or air at high relative humidity (RH). The durability problems with this material are reason that the material has so to speak been forgotten in the following years. However, within the last 10 years a relatively high number of so-called MgO products (MgO-boards) have been put on the market within the building industry. MgO-boards have a composition, which is very similar to hydrated Sorel cement but has both organic additions, such as sawdust (wood flour), and inorganic filler additions such as sand, lime or volcanic ash – even though it may not be stated in the data sheets for MgO-boards. Figure 7 shows a cut of an MgO-board analysed in a stereo microscope at 10 times magnification. The analysis shows that the investigated MgO-board contains a high amount of organic material such as wood fibres or sawdust, and a high number of fine spherical air pores. Figure 8 is a microanalysis of a thin section of a specimen at 50 times magnification that verified both the considerable

amount of very porous organic material and the many fine spherical air pores. All investigated MgO-boards have some type of fibrous reinforcement (glass fibre mesh) on the faces.

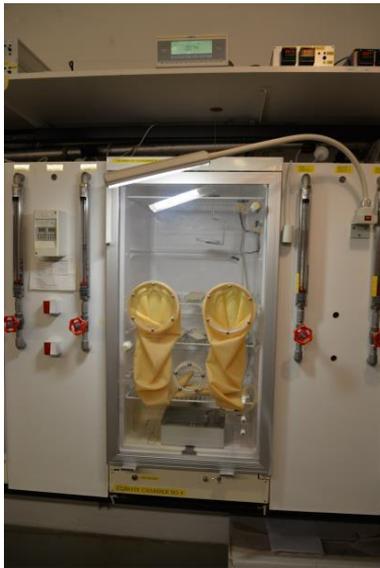
Figure 9: The climate chamber.

in a petri glass dish, which was placed inside a basket made of Teflon. Weighing of the baskets were performed without opening the front doors of the climate chambers, as the baskets were hung up one by one below the balance by means of a steel string. Figure 9 shows the climate chamber where the actual RH is created by mixing flow of dry air with flow of saturated air. Based on a calibrated RH-sensor the connected PID-system regulates the dry airflow and the saturated air flow for obtaining the wanted RH. In this way, the RH is created in wanted steps. Figure 10 shows the specimens in the petri glass dishes placed in the baskets. The measurements were performed after 0, 1, 2, 3, 4, 5, 7 days and after 2 and 4 weeks. The results are presented in Figures 11, 12 and 13. Indication of mould growth on specimen 4.4C was seen after 30 days of exposure to 95% RH, cf. Figure 14.

Subsequent measurements of absorption and desorption were performed for the same four specimens that were analysed for initial moisture absorption at 35% RH and 80% RH, i.e. the initial dry masses were known. The climate chamber used is shown in Figure 9. Desorption was measured for specimens 3.1B, 3.2B, 4.4B and 4.7B, which originally were used for determination of initial moisture absorption at 80% RH. Before starting the desorption runs, the humidity of the climate chamber was increased from 80% RH to 92% RH in steps of 2% RH with the purpose of finding the level of RH at which the specimens began to form drops (i.e. sweating or 'crying') on the surface. We knew from the first part of the tests (at 95% RH) that specimens showed severe sweating starting after one week, while boards at 80% RH apparently did not sweat after 80 days of exposure. In view of the risk of mould growth at RH higher than 92% RH, desorption was started at this RH. Desorption points were measured from 92% RH and below.

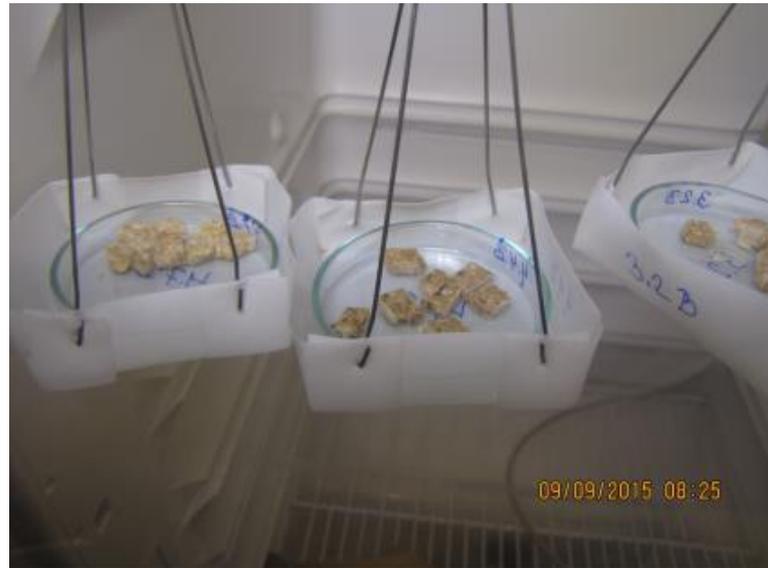
Figure 10: Specimens in the petri glass dishes placed in baskets.

The initial moisture absorption in MgO-boards from the surrounding air was measured at three different levels of relative humidity at 23 °C: 35% RH, 80% RH and 95% RH. Before start of the moisture exposure, samples of size 5 x 4 x 3 mm were dried at 105 °C for 4 days, and cooled to room temperature. MgO-samples with a total weight of about 2 g were placed

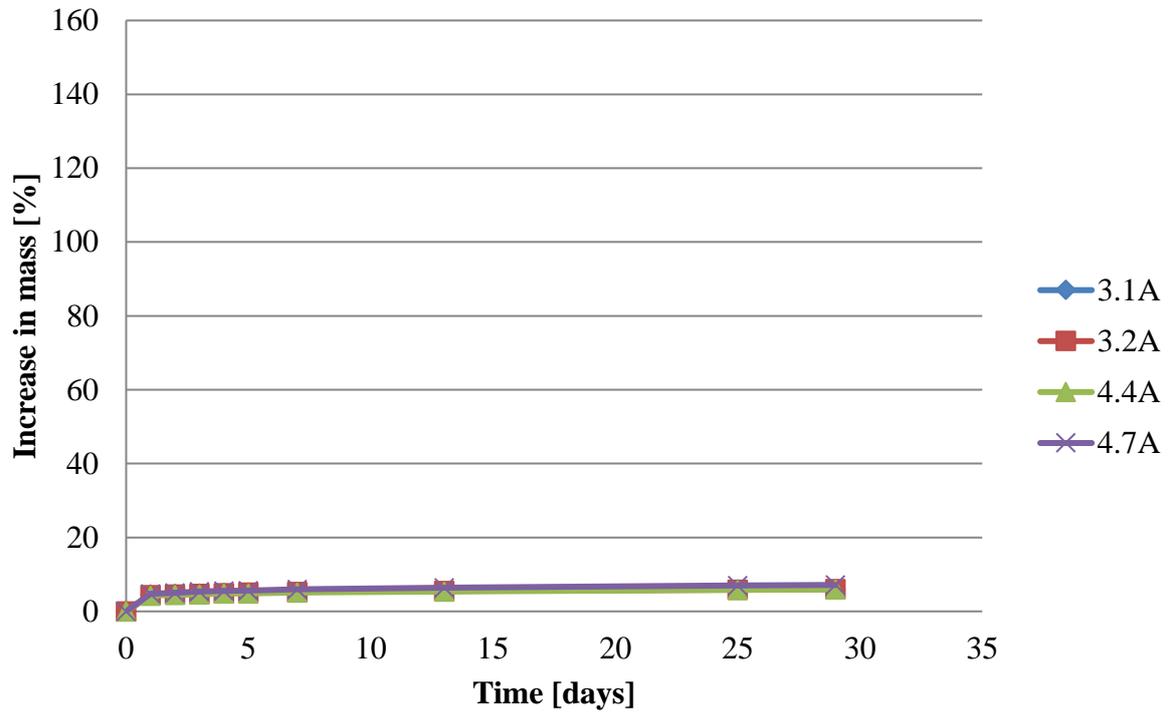
Figure 11: Course of the moisture retention at 35% RH.

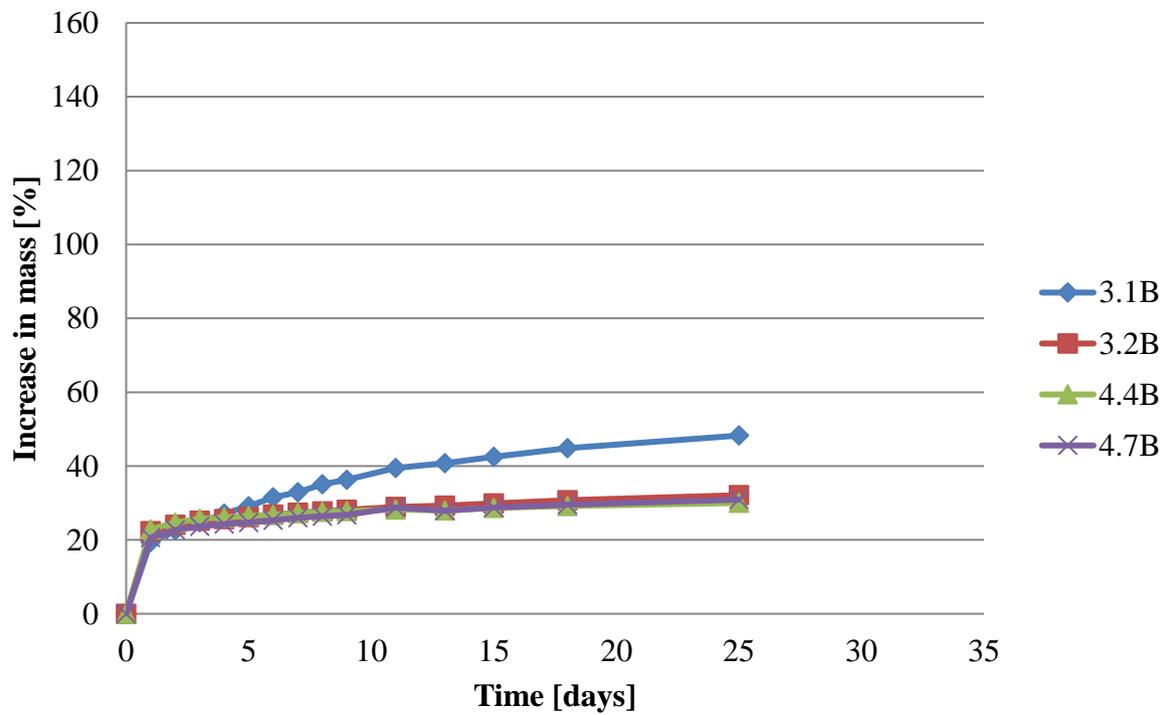
Figure 12: Course of the moisture retention at 80% RH.

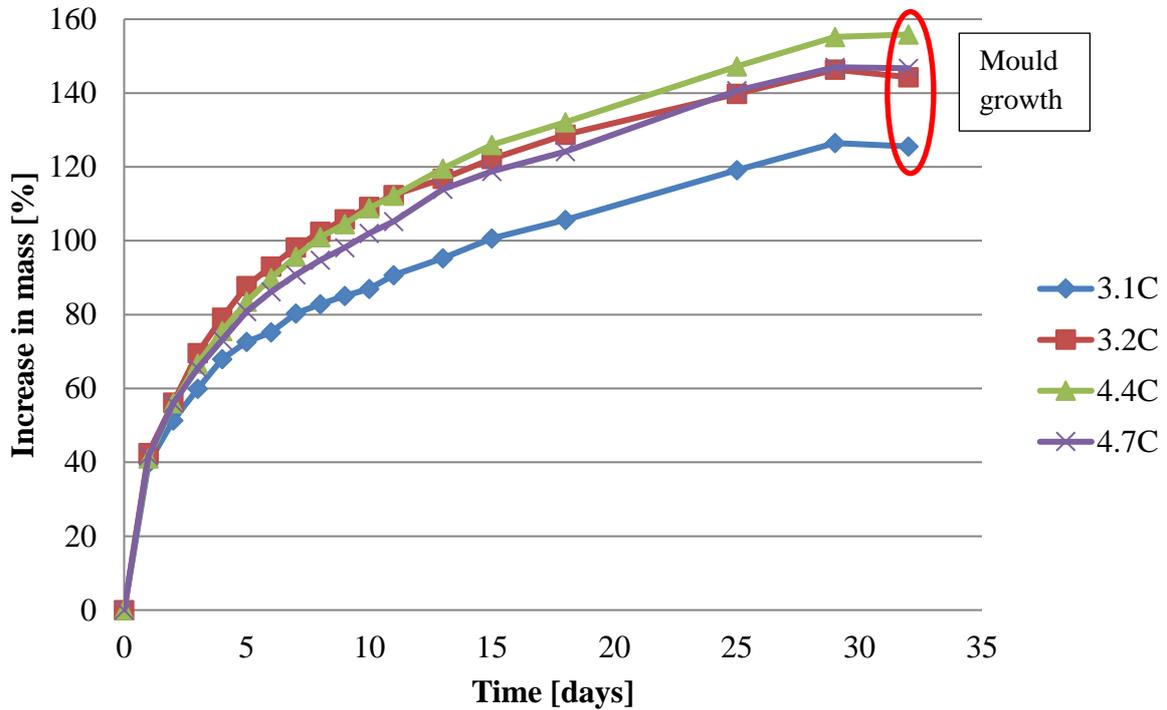
Figure 13: Course of the moisture retention at 95% RH.

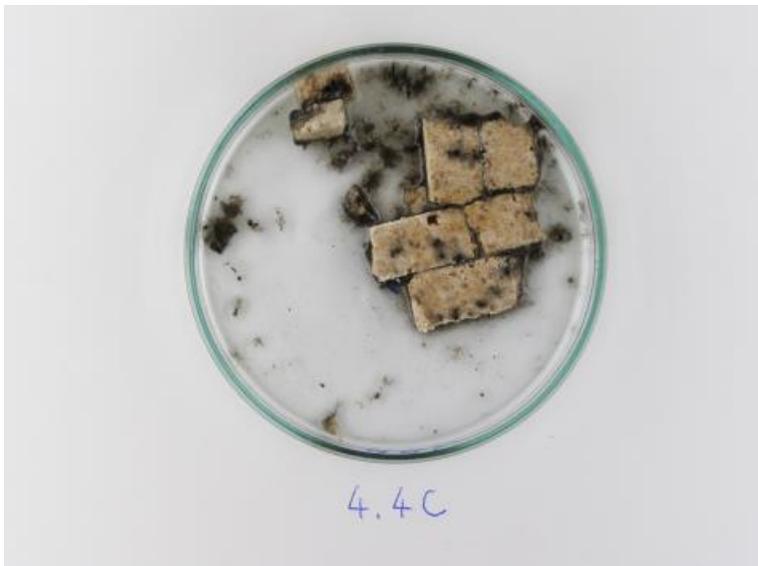
Figure 14: Indication of mould growth on specimen 4.4C after 30 days of exposure to 95% RH.

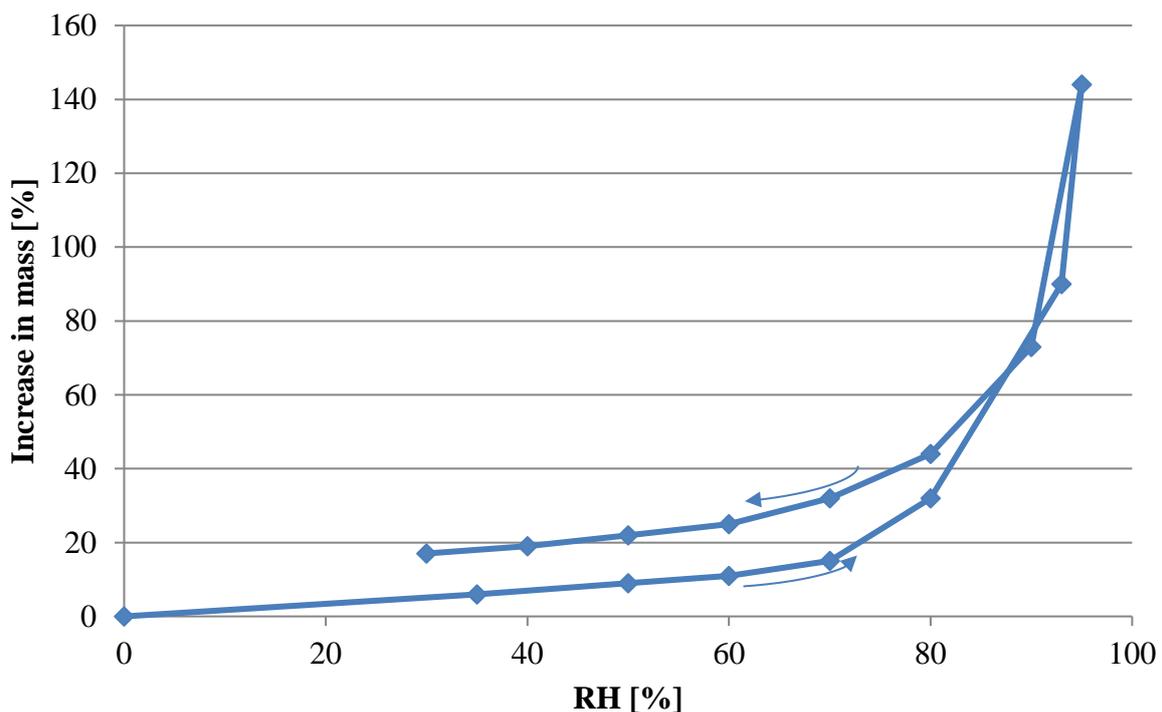
Figure 15: The results of the absorption and desorption measurements for specimen 3.2.

Absorption was measured for specimens that were originally used for initial moisture absorption at 35% RH. The absorption points were measured from 35% RH and up to 92% RH. An example of the results of the absorption and desorption measurements is shown in Figure 15.

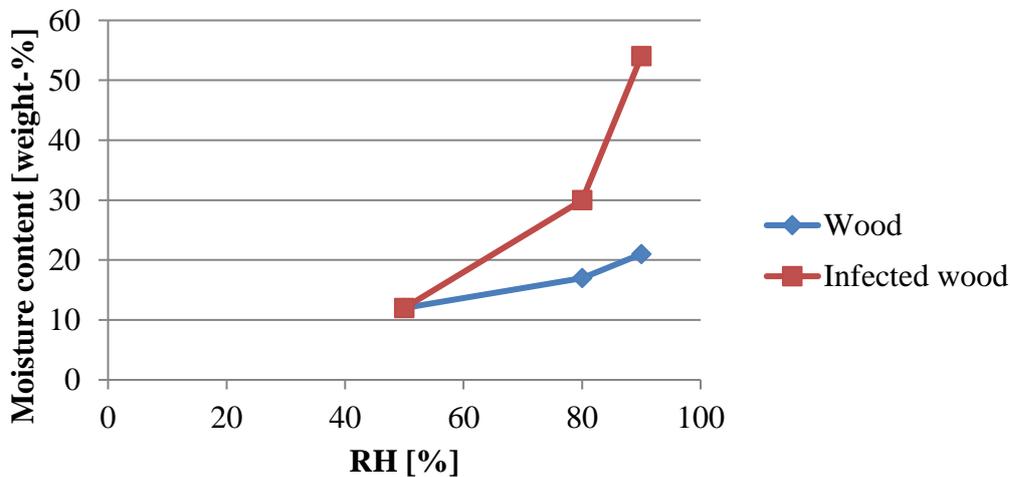
Figure 16: The absorption curves for the infected wood and the non-infected wood.

The pine wood posts supporting the adjacent MgO-boards inside the façade construction absorb the water drops ('tear' drops) from the MgO-boards. The 'tear' drops contain relatively high amounts of chloride ions. Infected wood from a post from a house, as well as non-infected wood, have been used for absorption measurements as follows: First, the infected wood and the non-infected wood pieces were conditioned to attain equilibrium at 50% RH. They were then conditioned to equilibrium at 80% RH, and finally to equilibrium at 90% RH. The absorption curves for the infected wood and the non-infected wood are shown in Figure 16.
